Manhole Inspection Summary

Manhole # S17G__012MH

Insp Date: **10/4/07 3:42 PM**

Location Address: **2401 LEXUBGTON-FAYETTE** Cross Street: **WHEELER AVE**

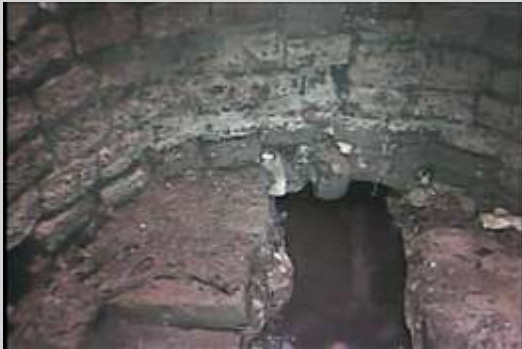
12 O'Clock Outflow

8 in. Circular Gravity Sewer
Pipe Out @ 12 O'Clock

Pipe Height: **8.4** (in.) Rod and Bar (Angled)
Pipe Material: **Clay** ☐ Pipe Lined
Invert Depth: **9.80** (ft.) Flow Characteristics: **Slow**
Deposits: ☒ None ☐ Mud ☐ Sludge ☐ Debris ☐ Grease
Silt Depth: (in.) Deposits Extent:
Infiltration: **None** Pipe Seal Cond: **Sound**

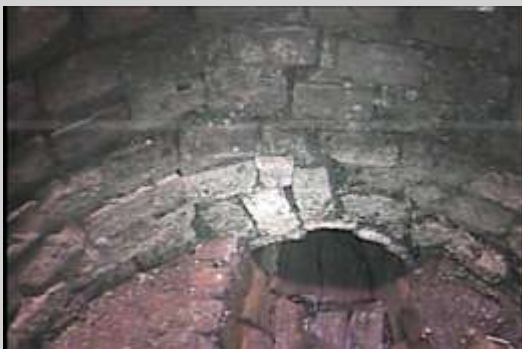
6 O'Clock Inflow

8 in. Circular Gravity Sewer
Pipe In @ 6 O'Clock

Pipe Height: **7.2** (in.) Rod and Bar (Angled)
Pipe Material: **Clay** ☐ Pipe Lined
Invert Depth: **9.21** (ft.) Flow Characteristics: **Slow**
Deposits: ☒ None ☐ Mud ☐ Sludge ☐ Debris ☐ Grease
Silt Depth: (in.) Deposits Extent:
Infiltration: **None** Pipe Seal Cond: **Sound**
